Manhole Inspection Summary

Manhole # S39KK_038MH

Insp Date: **1/22/08 9:22 AM**

Location Address: **1733 ENSOR ST**

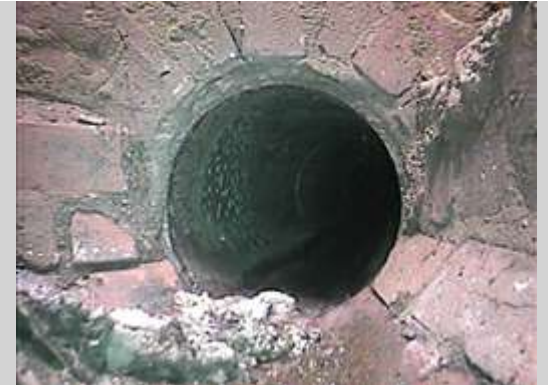
12 O'Clock Outflow

8 in. Circular Gravity Sewer
Pipe Out @ 12 O'Clock

Pipe Material: **Clay** ☐ Pipe Lined

Invert Depth: **7.00** (ft.) Flow Characteristics: **Slow**

Deposits: ☒ None ☐ Mud ☐ ~~Gravy~~ ☐ Debris ☐ Grease

Infiltration: **None** Pipe Seal Cond: **Sound**

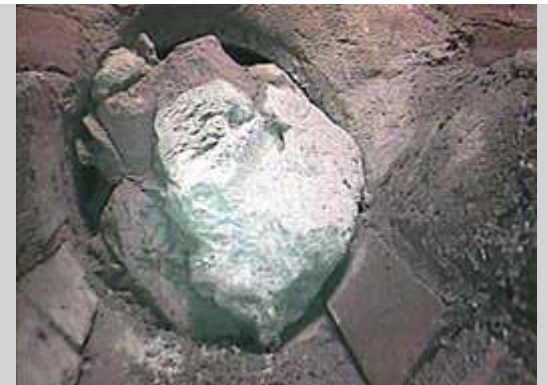
6 O'Clock Inflow

8 in. Circular Gravity Sewer
Pipe In @ 6 O'Clock

Pipe Material: **Clay** ☐ Pipe Lined

Infiltration: **None** Pipe Seal Cond: **Unknown**
